Thorpe-le-Soken Maltings, Essex. May 2003

Ian Peaty

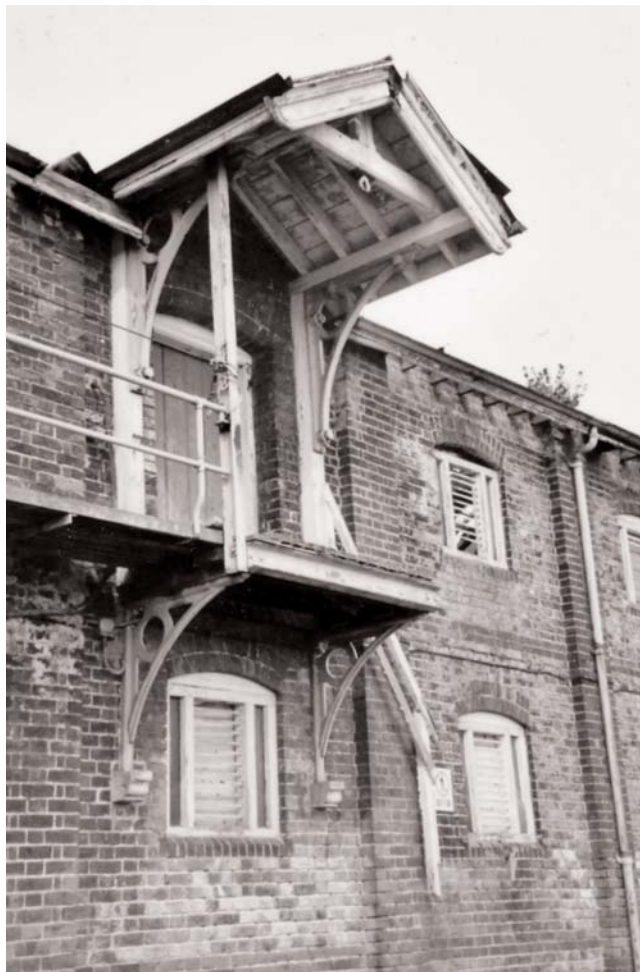
Free Rodwell & Co Ltd. Detail of lucam and its spandrels; sacks were lifted up via the intact loop on cross beam of roof. Previous access to external landing and lucam, stairs demolished to right, handrail partially remains. Note contrasting brickwork and window details.

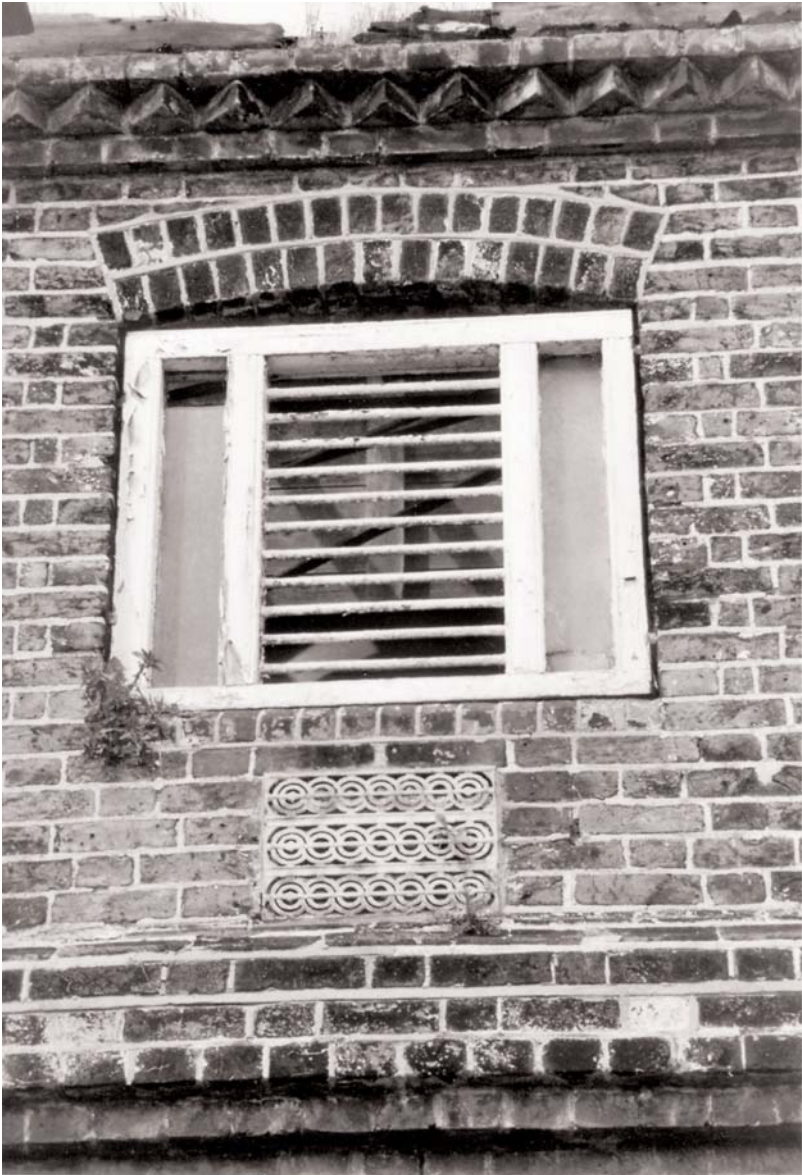
Detail of window and metal ventilation grill below. Note dentil course of contrasting red bricks to roof eaves (gutter missing).

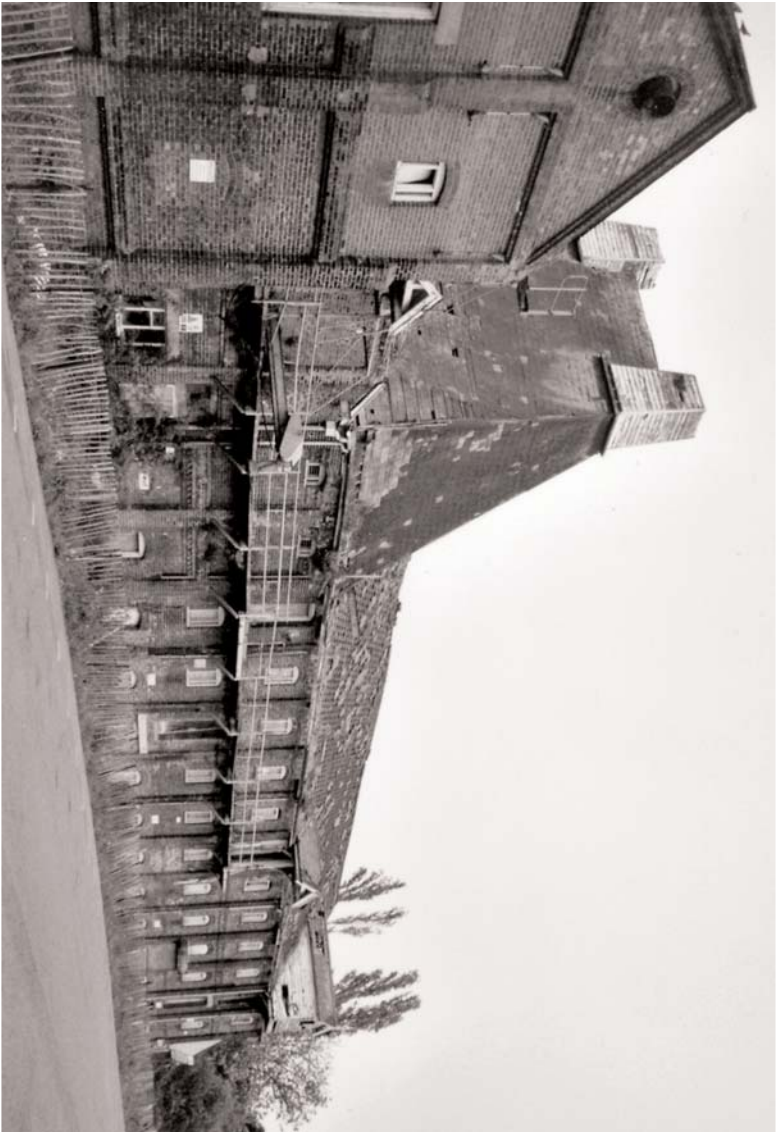
Double kiln flues and automatic spent grains discharge from external walkway. Note the two styles of lucam.

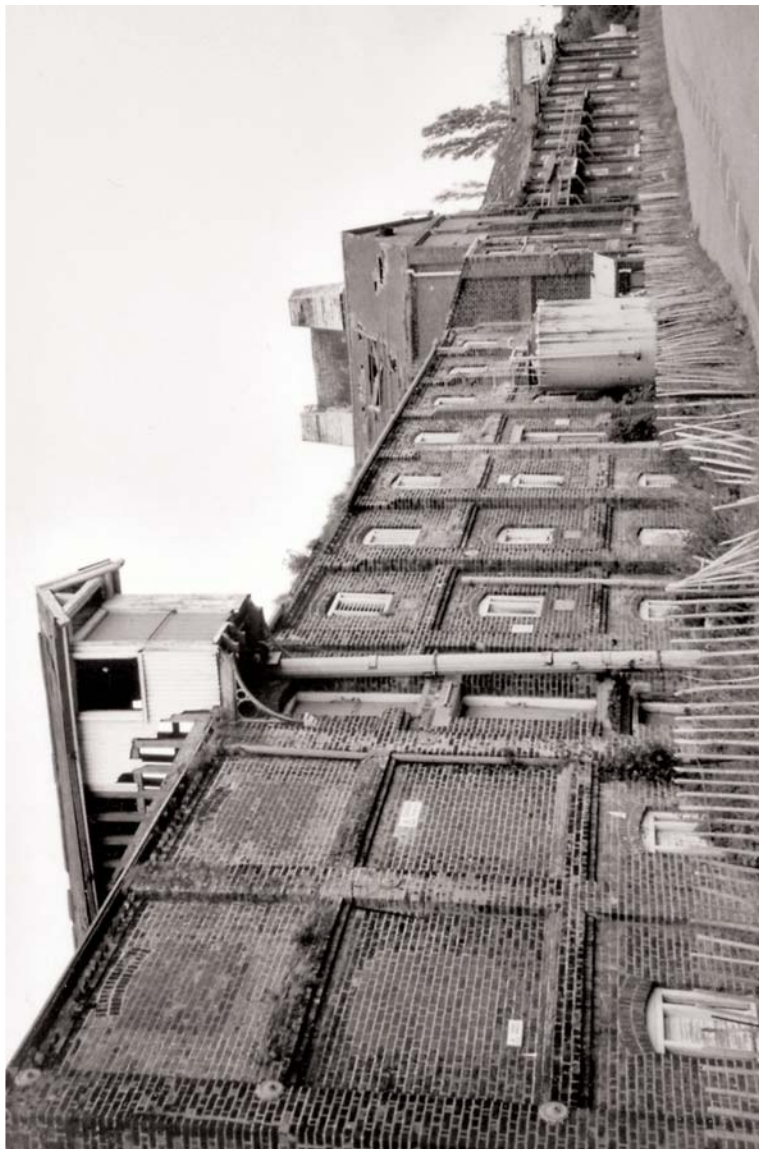
View of the whole length of premises, derelict since about early 1970s. This shows how the three central kilns in effect worked two growing floor buildings. The pipe beside nearest lucam is suction feed for barley intake.

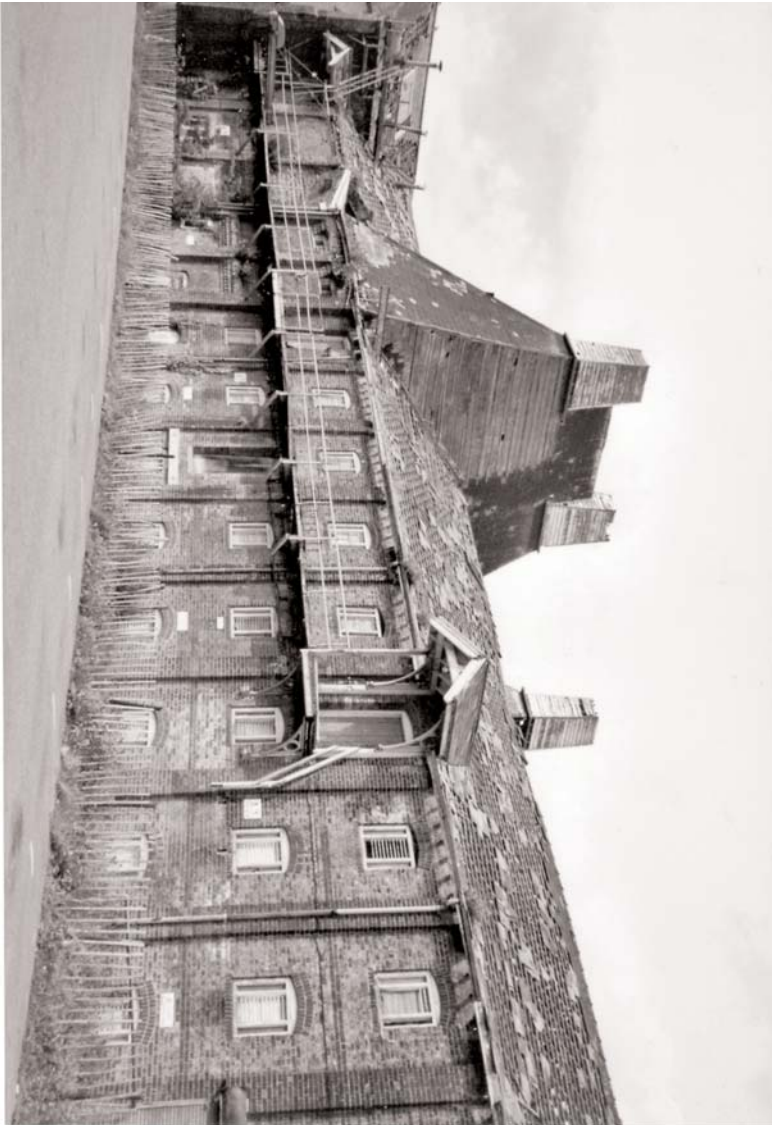
Rail sidings of goods yard formerly in front, now a car park for commuters to London. Closed since at least the early 1970s.

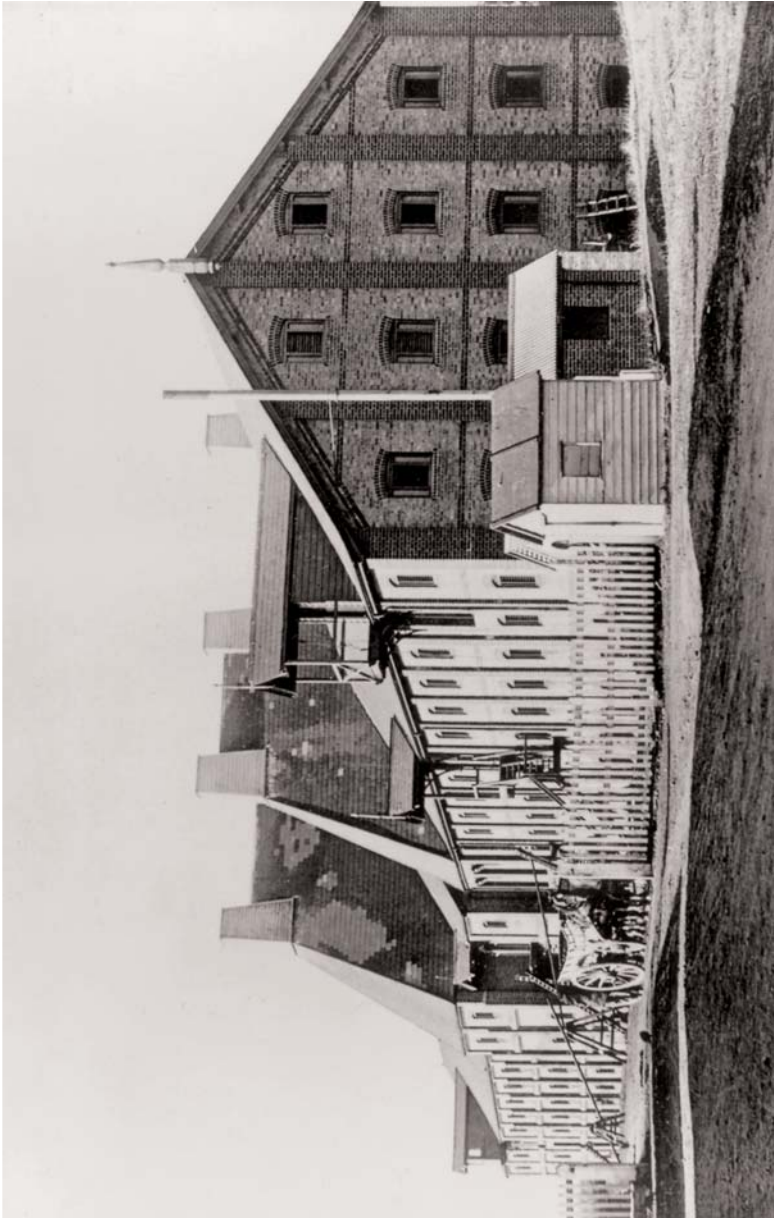
Free, Rodwell & Co Ltd Malting beside the railway station, taken over by Ind Coope / Albrew malsters. View c. 1890s
