## WARMINSTER MALTINGS, POUND STREET, WARMINSTER

SANDRA BATES

### Introduction

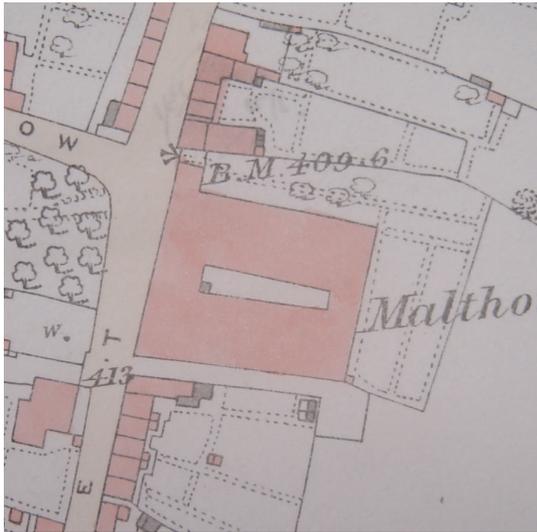
Figure 1. 1886 OS Map. Courtesy of Wiltshire & Swindon History Centre.

By 1886 the building is on its current footprint as shown on the Ordnance Survey map [Fig. 1].

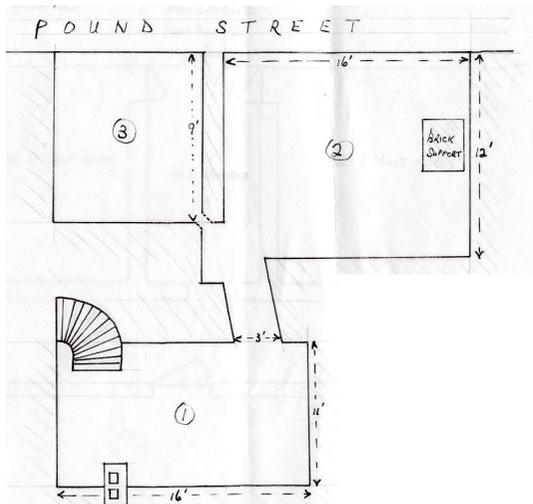
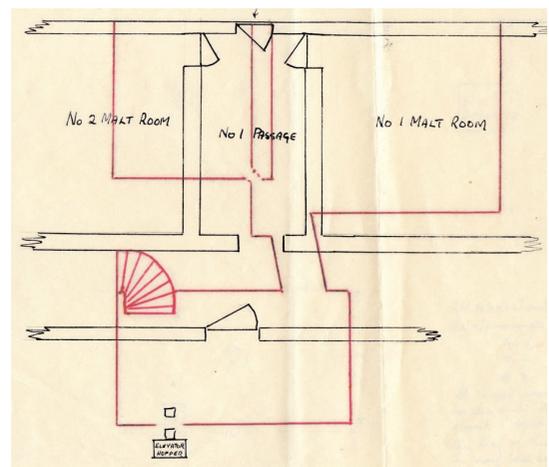
Figures 2 and 3. 1950s cellar and ground floor plan. Source: Dewey Museum, Warminster, Beaven Archive, Box 69.

Plans of the cellars from the 1950s [Figs. 2 and 3], found amongst archive material in Warminster Museum, show that the dividing walls of the cellars do not align with the ground floor walls and that an extra wall has been constructed in the cellar blocking off access to one section.<sup>2</sup> The wall was presumably built to help support the load above; a large brick pillar also provides support for the ground floor. The surveyor noted that he was unable to measure cellar 3 as the access was only one foot wide.

Two blocked windows are present in cellar 1 and inspection by the author has confirmed that these are now below ground level

Dorothy Treasure, of the Wiltshire Buildings Record, carried out an examination of the cellars in 2011, and concluded that the cellars were late 18<sup>th</sup> C., in common with most of the housing in Pound Street.<sup>3</sup> This would indicate that they formed part of the original house. At first floor level, two timber-framed walls complete with brick infill, form part of one of the redundant kilns, these walls may be another legacy of the house.

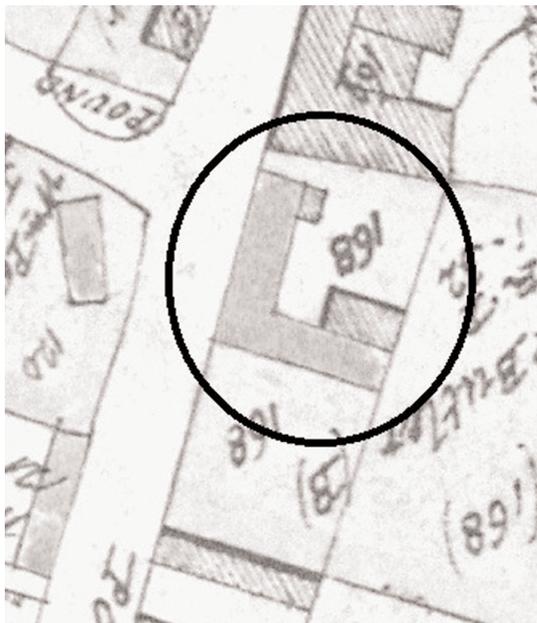
Figure 4. Enclosure map. Courtesy of Wiltshire & Swindon History Centre.

The Enclosure [Fig. 4]<sup>5</sup> and Tithe<sup>6</sup> Maps of 1784 and 1840 respectively both show an ‘L’ shaped building on the maltings site; however, the building was coloured pinkish-orange on the enclosure map and solid black on the tithe, both formats indicating that it was residential. A crooked field and property boundary seen on the 1886 OS map is also visible on the Enclosure and Tithe maps and provides a datum point when comparing maps and plans.

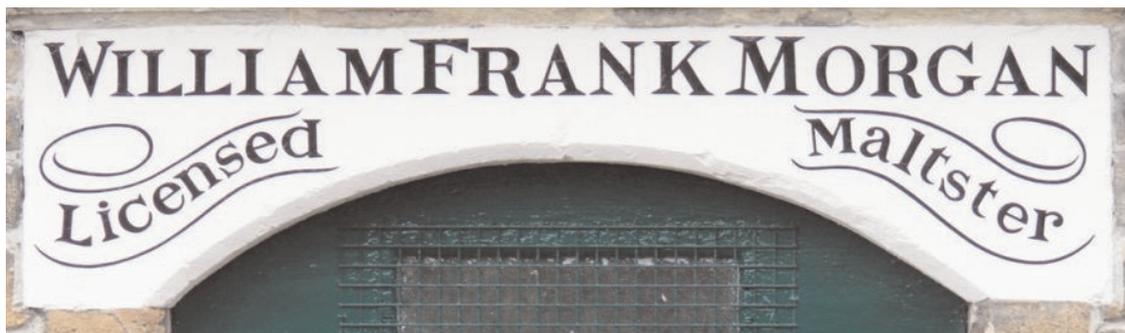
Figure 5. Carved and painted lintel to the door of the southern building. Copyright, the author.

- Reputed to be 18<sup>th</sup> C
- Altered and rebuilt in 1879 for the Morgan family
- Second door from the left is late 19<sup>th</sup> C
- There is a door lintel painted in mid 19<sup>th</sup> C lettering 'William Frank Morgan Licensed Maltster'.

To date there is no documentary evidence to prove that he carried out his plans; however, he was obviously proud enough of his building to erect a carved door lintel [Fig. 5] with his name when a simple wooden sign would have sufficed!
